Oak Cottage

Cultural Resource Evaluation

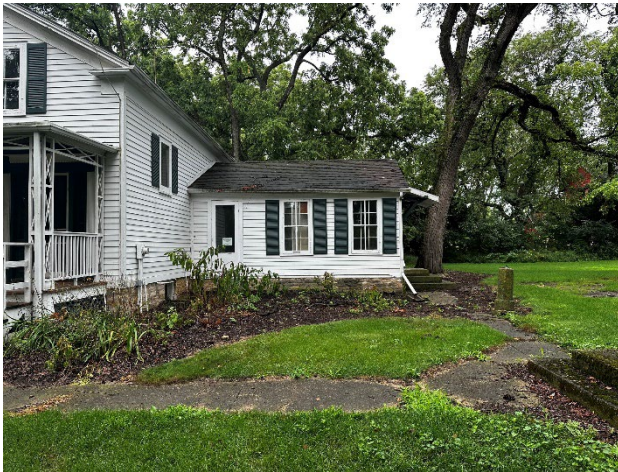
Figure 4. Concrete-paved walks adjacent to house.
(Source: All photographs by WJE, 2024, unless otherwise noted)

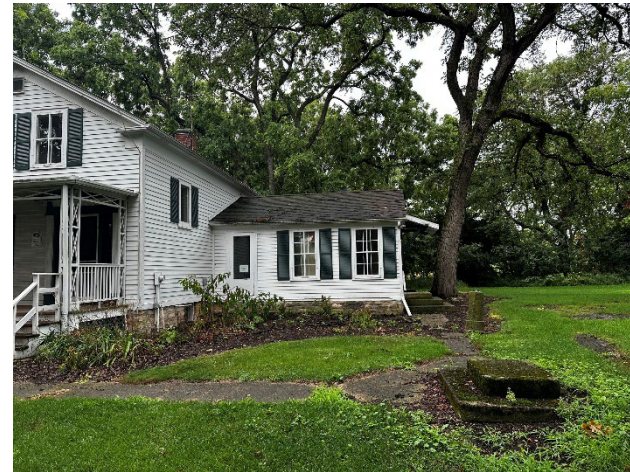
Figure 5. Concrete-paved walks and concrete mounting block (at right) adjacent to house.

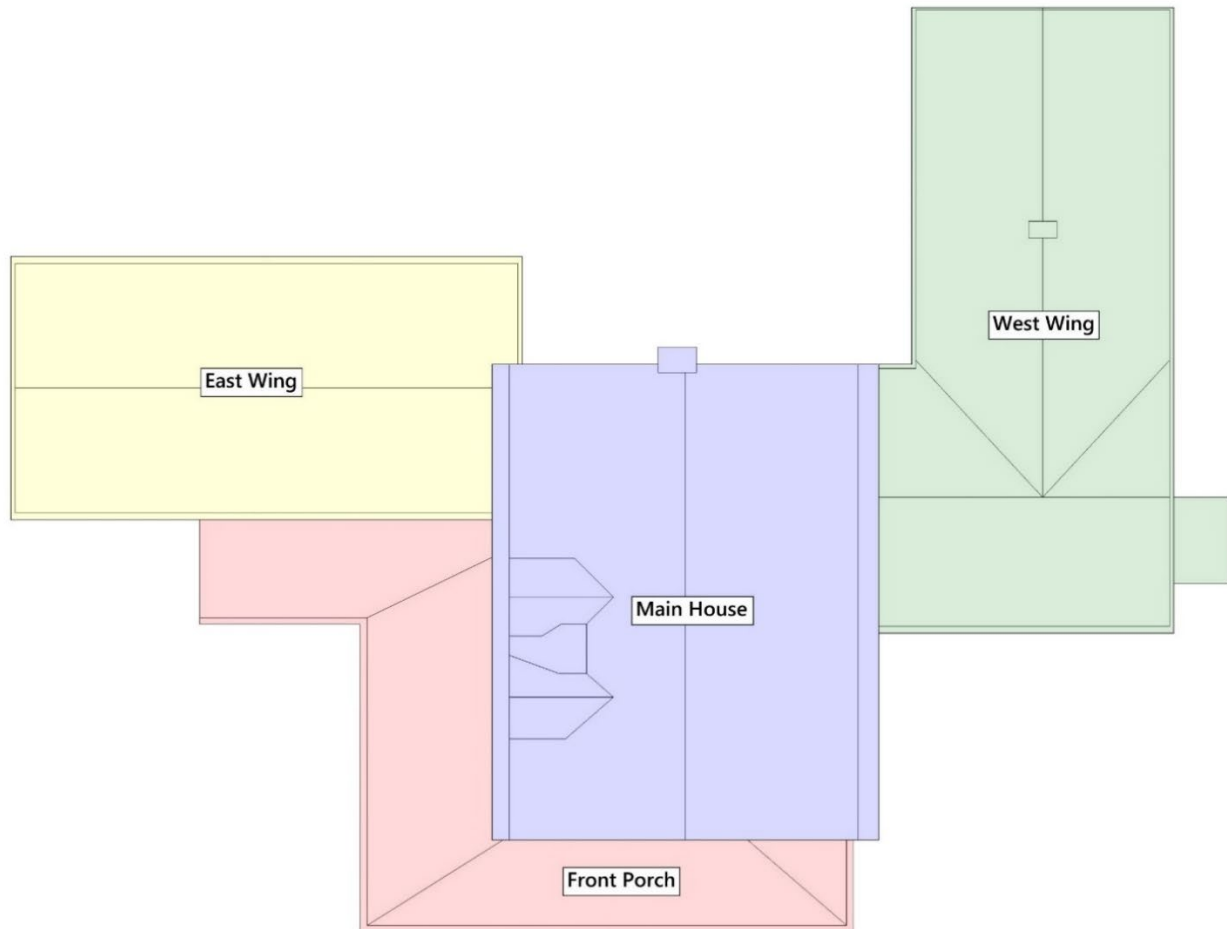
Figure 6. Roof plan of Oak Cottage showing different components of the house. (Source: WJE, 2024)

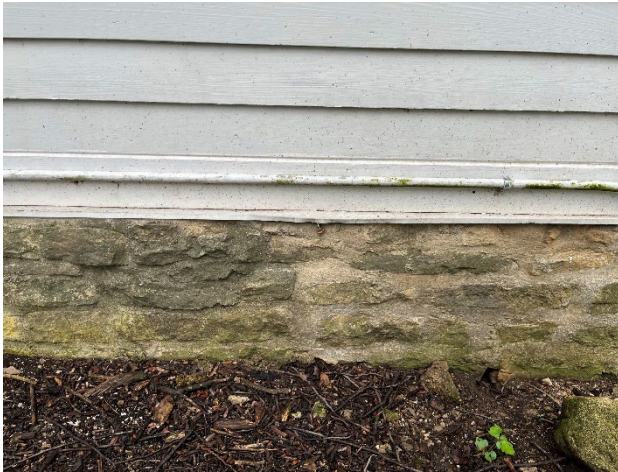
Figure 9. Stone foundation.

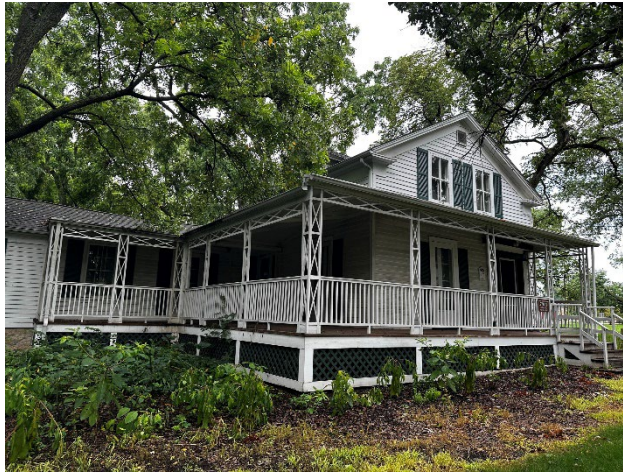
Figure 10. Wrap-around porch at north elevation.

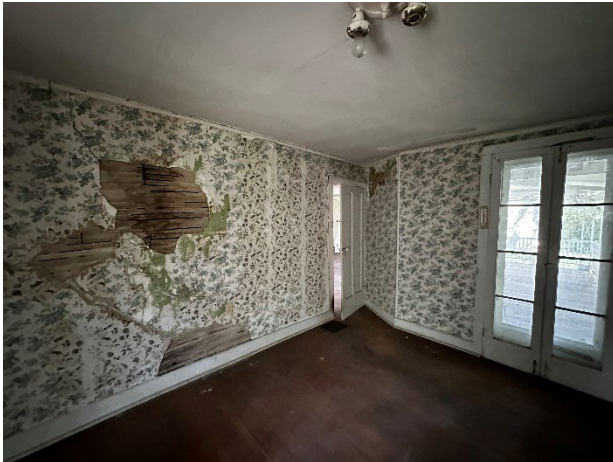
Figure 42. The east bedroom with doors leading to the front porch at right. An inspection opening was made as part of this study at the area of missing plaster at the left.

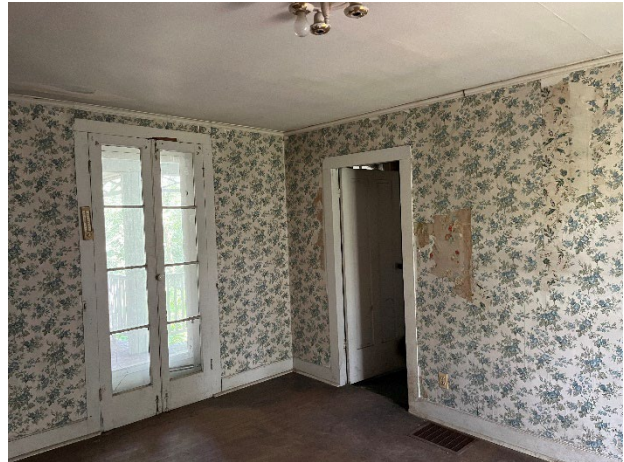
Figure 43. The closet at the east end of the east bedroom.

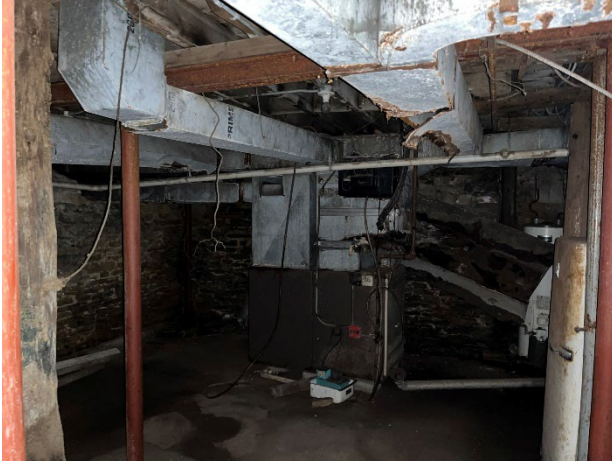
Figure 70. Basement from northwest corner.

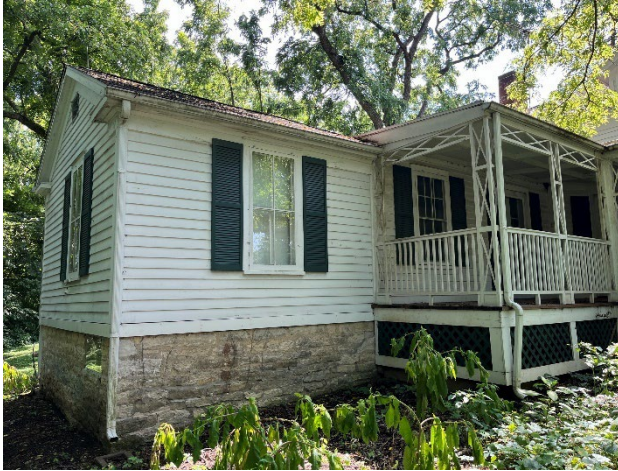
Figure 72. Step cracking in masonry mortar joints at northeast corner.

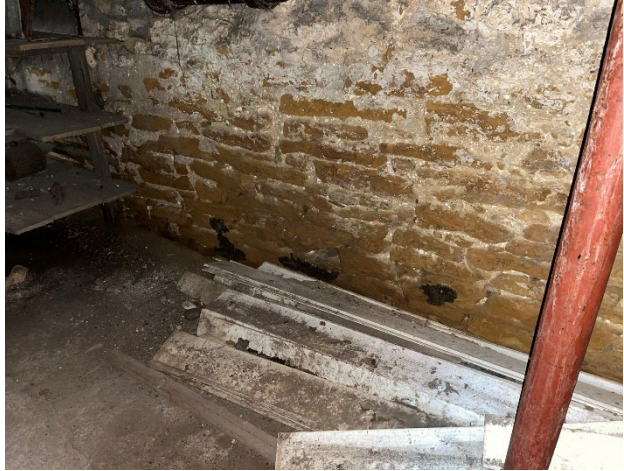
Figure 73. Deteriorated parge coat and open mortar joints at interior masonry stone foundation wall.

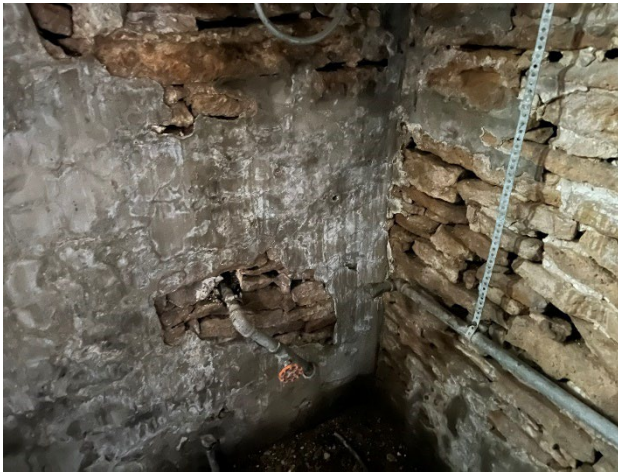
Figure 74. Water damage and efflorescence at interior masonry stone foundation wall.

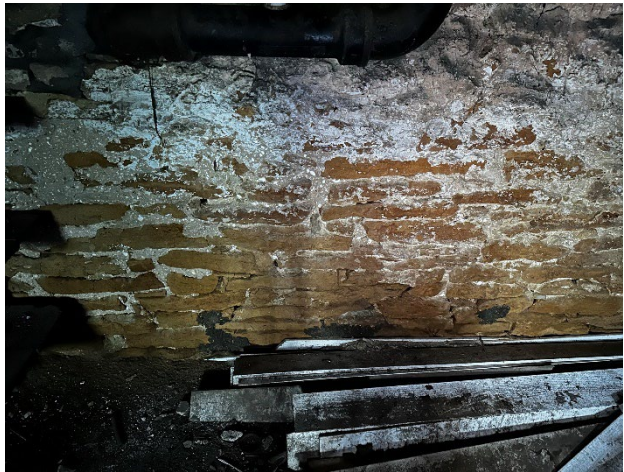
Figure 75. Open mortar joints at interior masonry stone foundation wall.

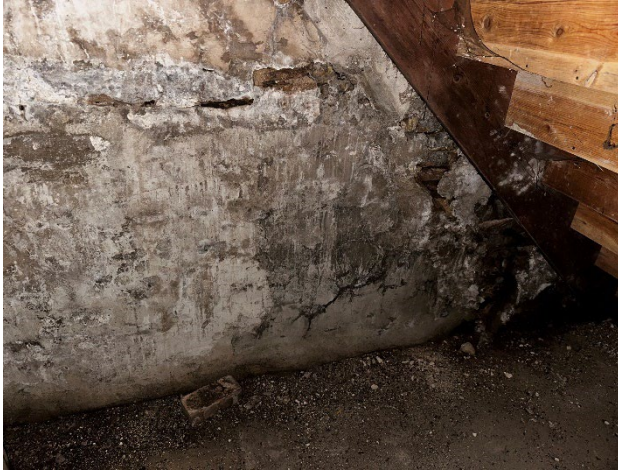
Figure 76. Water damage and efflorescence at interior masonry stone foundation wall.

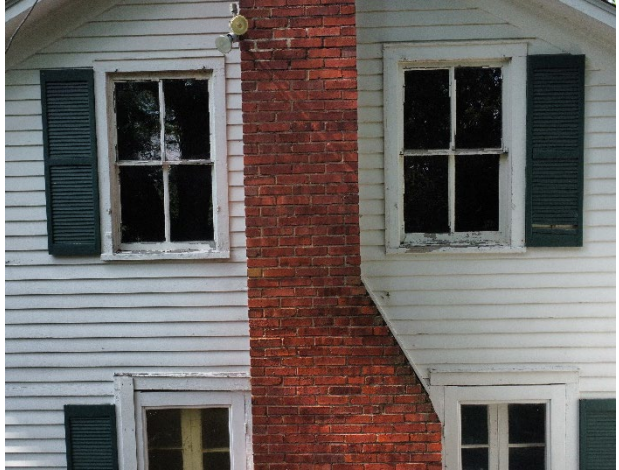
Figure 77. Deteriorated mortar joints at chimney on south wall.

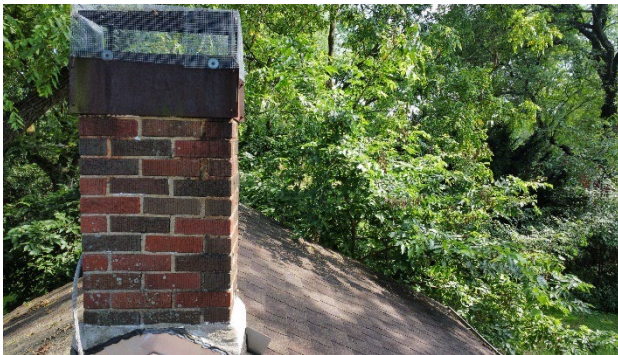
Figure 78. Minor masonry displacement at chimney over west wing.

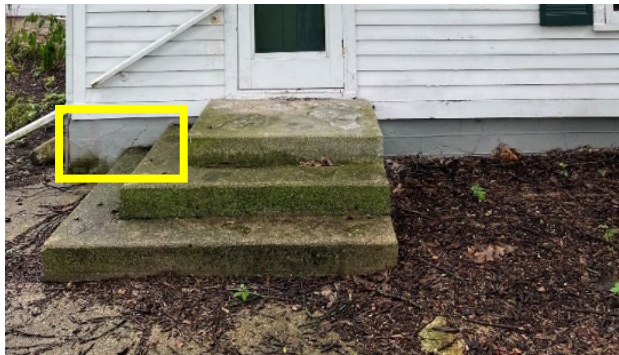
Figure 79. Biological growth and cracking at parge coat on west wing foundation (yellow box).

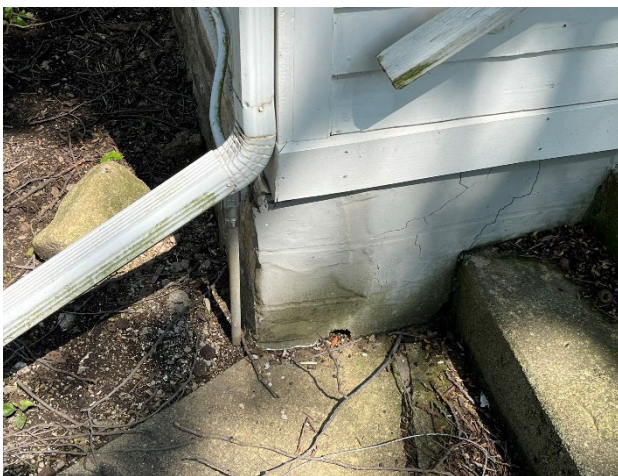
Figure 80. Biological growth and corner cracking at parge coat on west wing foundation.

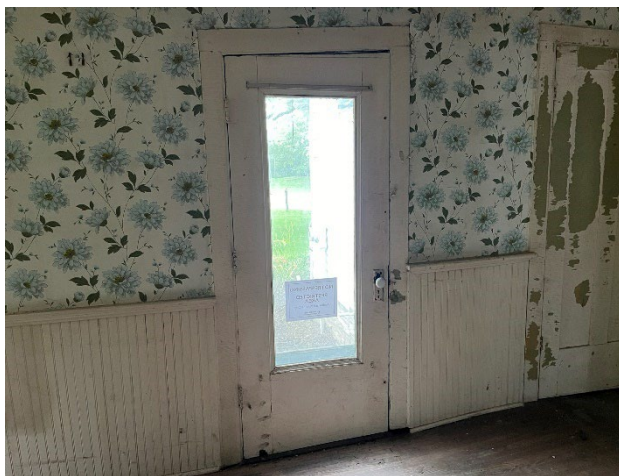
Figure 81. Evidence of past settlement at interior finishes in dining room.

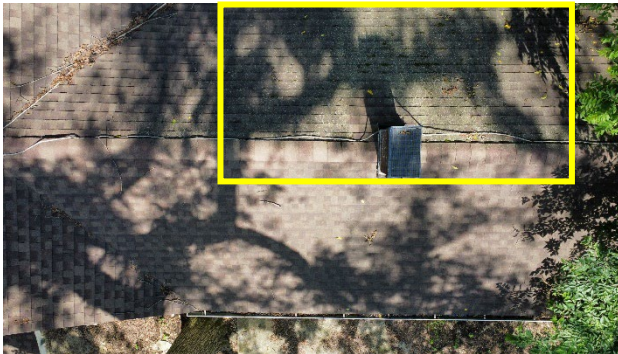
Figure 84. Biological growth on south side of gable roof at the west wing (yellow box).

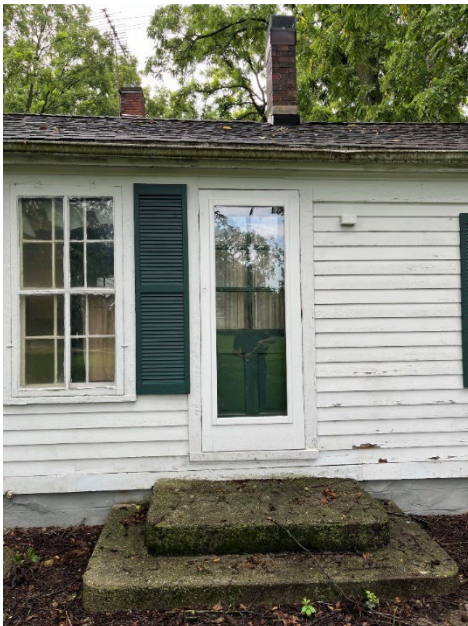
Figure 88. Paint failure at exterior wood components.

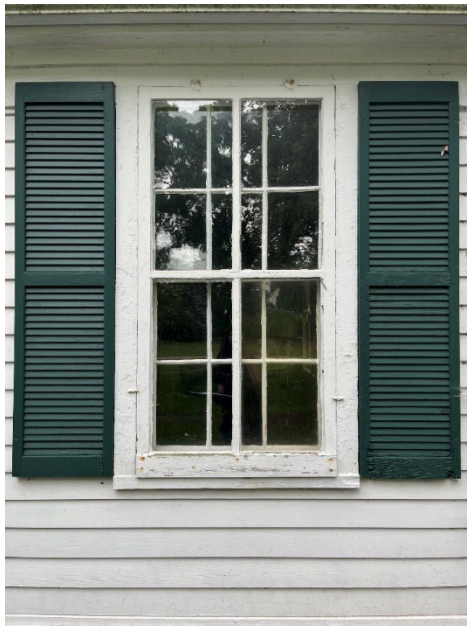
Figure 89. Paint failure at window framing.

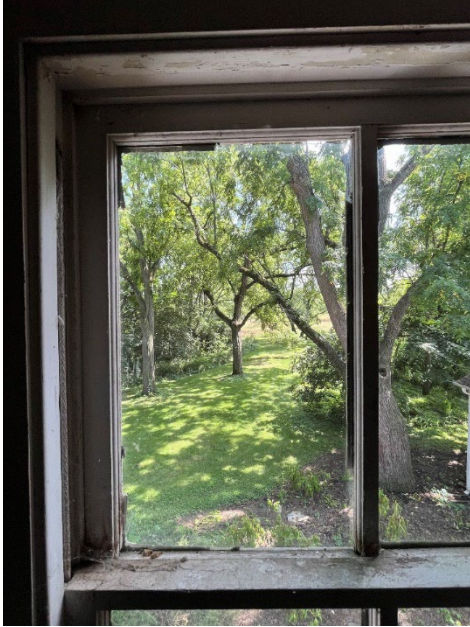
Figure 90. Deterioration of window glazing putty at second floor windows.

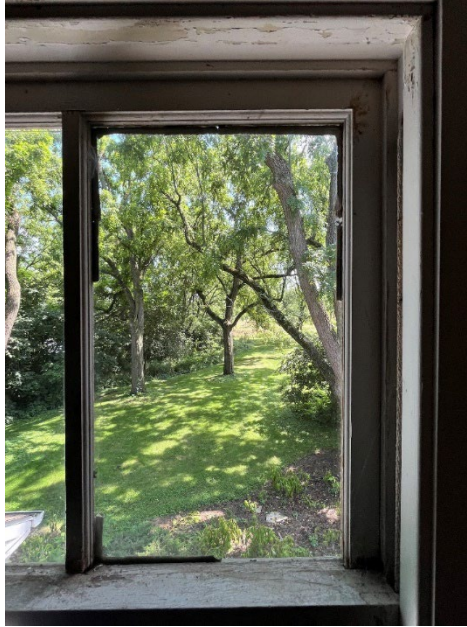
Figure 91. Deterioration of window glazing putty at second floor windows.

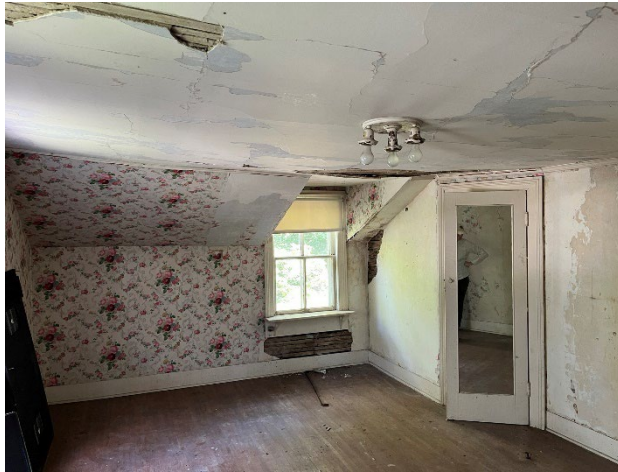
Figure 92. Cracked and deteriorated plaster at front bedroom ceiling.

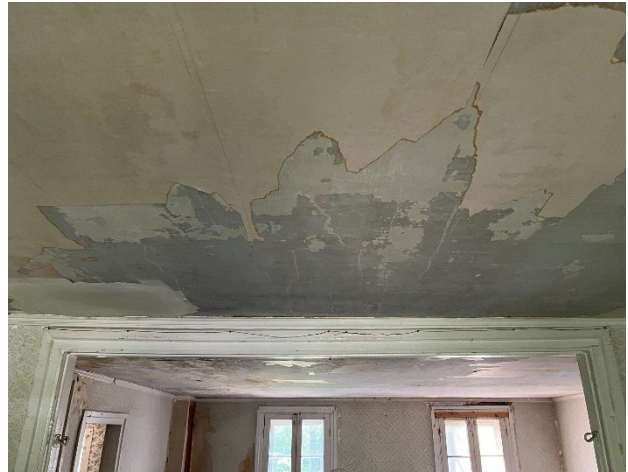
Figure 93. Cracked and deteriorated plaster at living room ceiling.

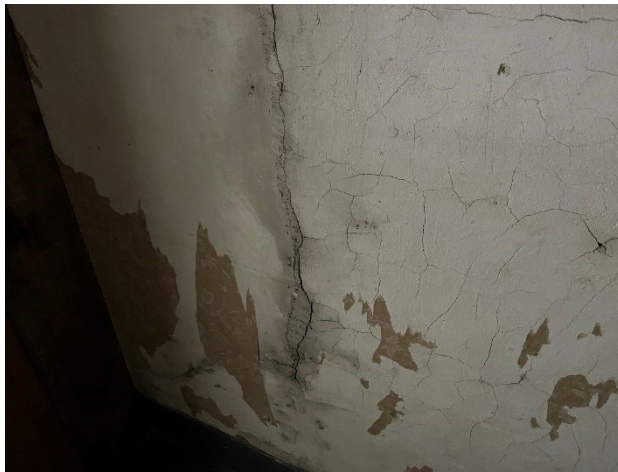
Figure 94. Cracked and deteriorated plaster at ceiling.

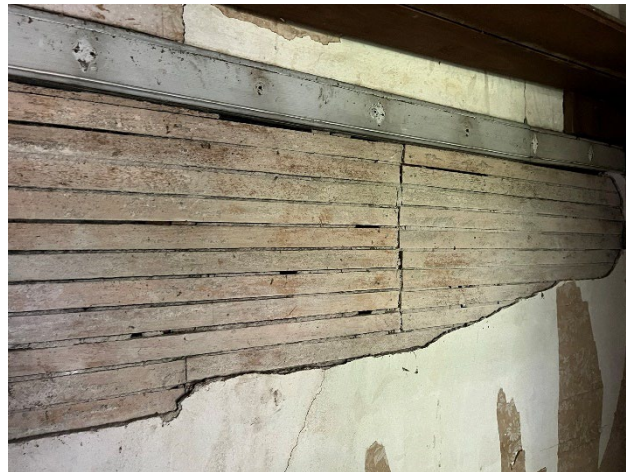
Figure 95. Missing plaster and exposed wood lath at wall.

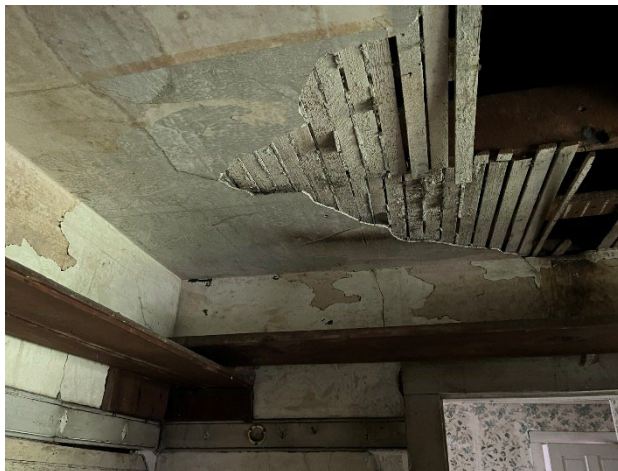
Figure 96. Cracked, deteriorated, and missing plaster at ceiling.

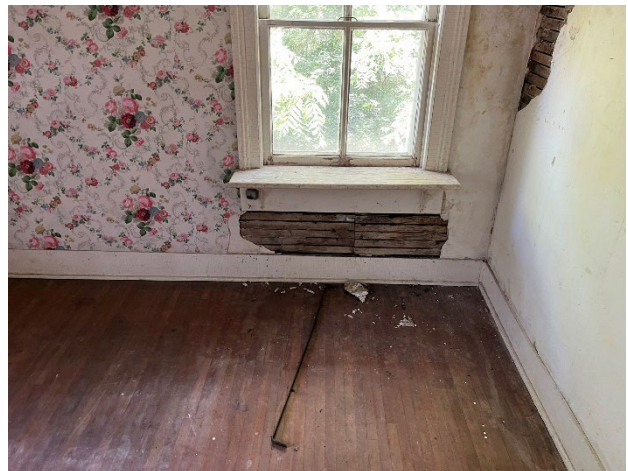
Figure 97. Cracked, deteriorated, and missing plaster at front bedroom wall.

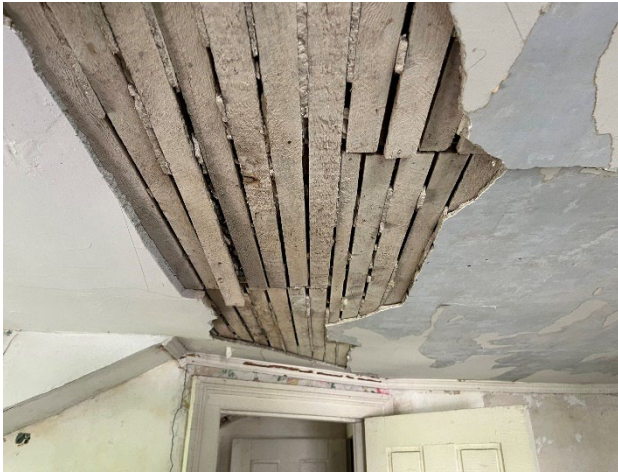
Figure 98. Cracked, deteriorated, and missing plaster at front bedroom ceiling.

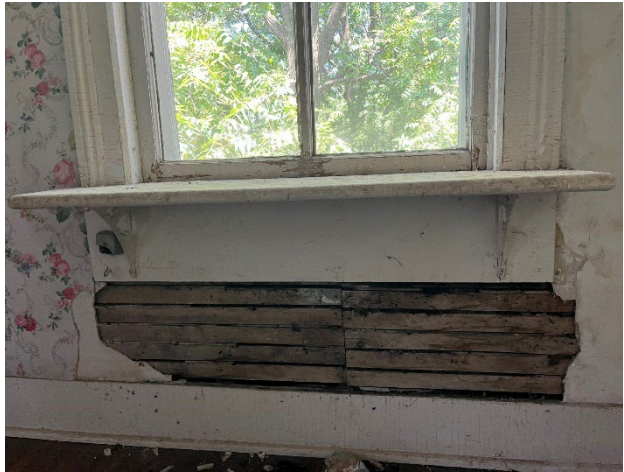
Figure 99. Missing plaster and exposed wood lath.

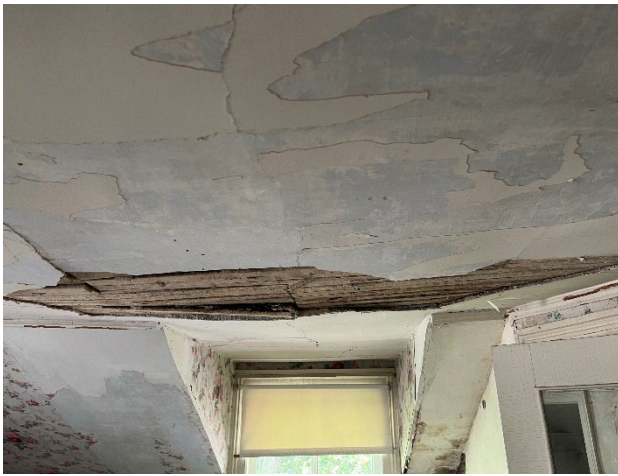
Figure 100. Damaged wood lath at plaster ceiling.

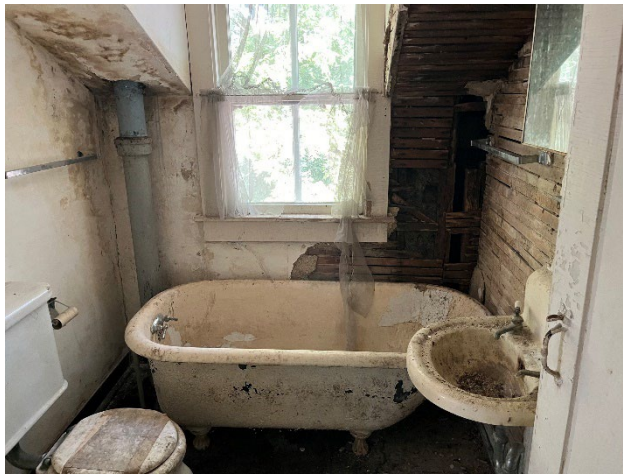
Figure 101. Extensive plaster damage and exposed wood lath at second floor bathroom.

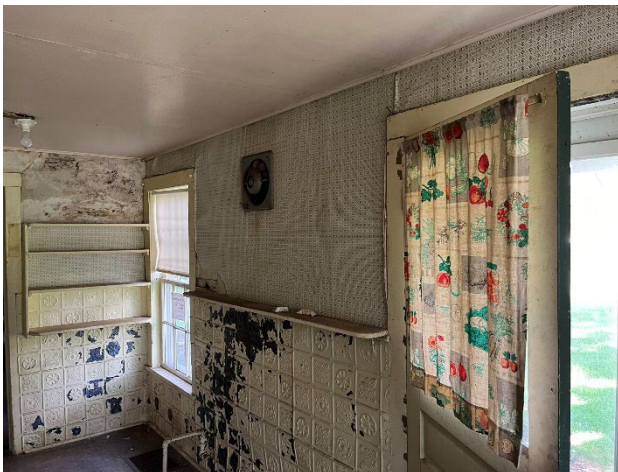
Figure 102. Peeling and flaking paint at interior finishes.

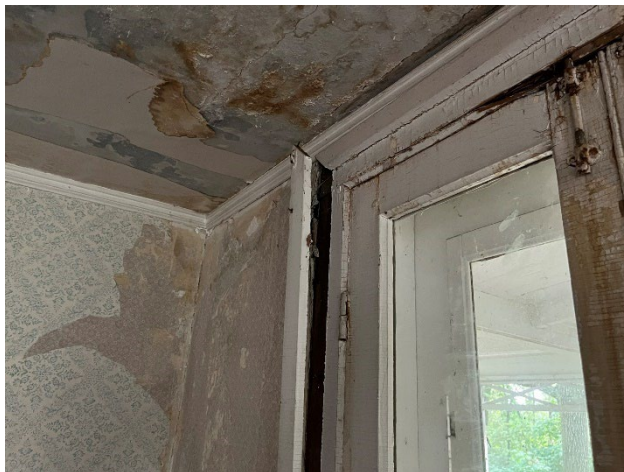
Figure 103. Water damage and deteriorated plaster wall.

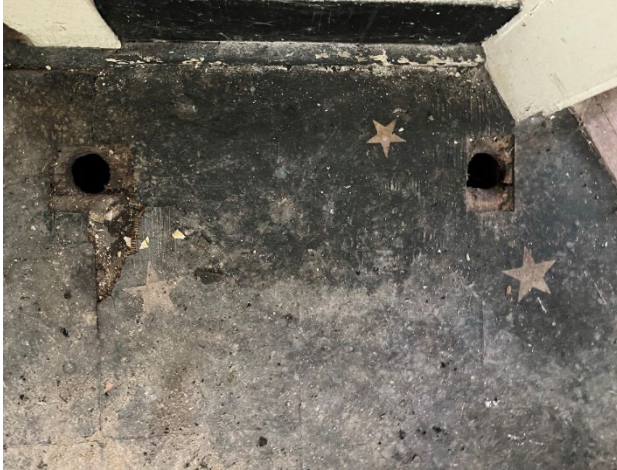
Figure 104. Water damage at second floor bathroom.

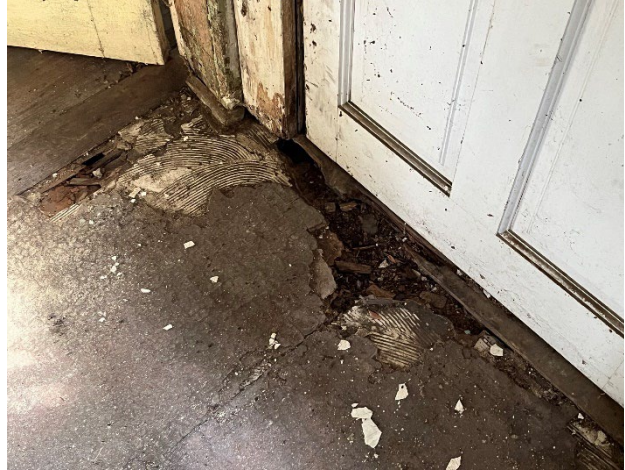
Figure 105. Water damage and deterioration at floor. Of second floor bathroom.

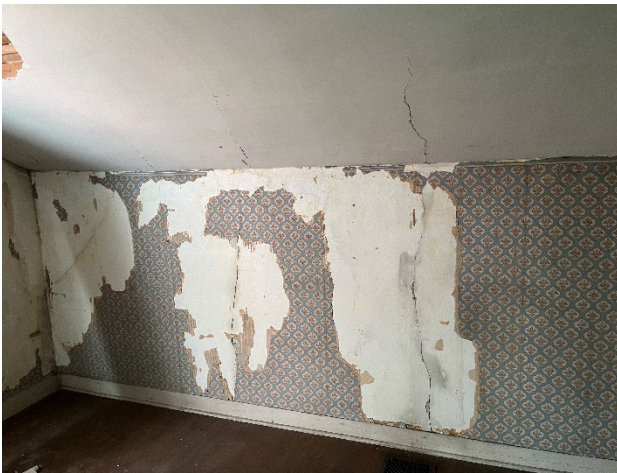
Figure 106. Peeled and missing wallpaper at cracked and damaged plaster at bedroom.

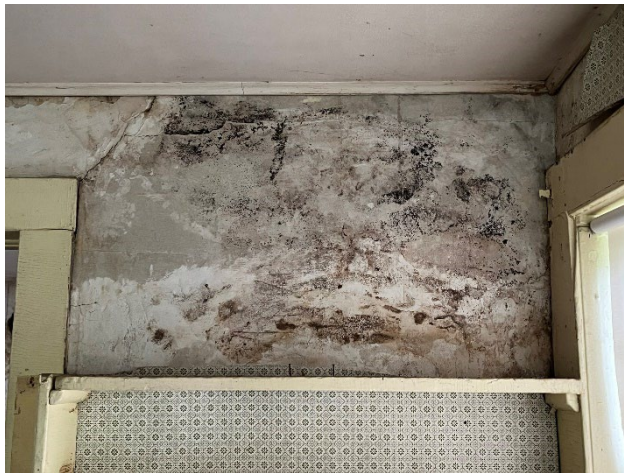
Figure 107. Biological growth on plaster at kitchen wall.

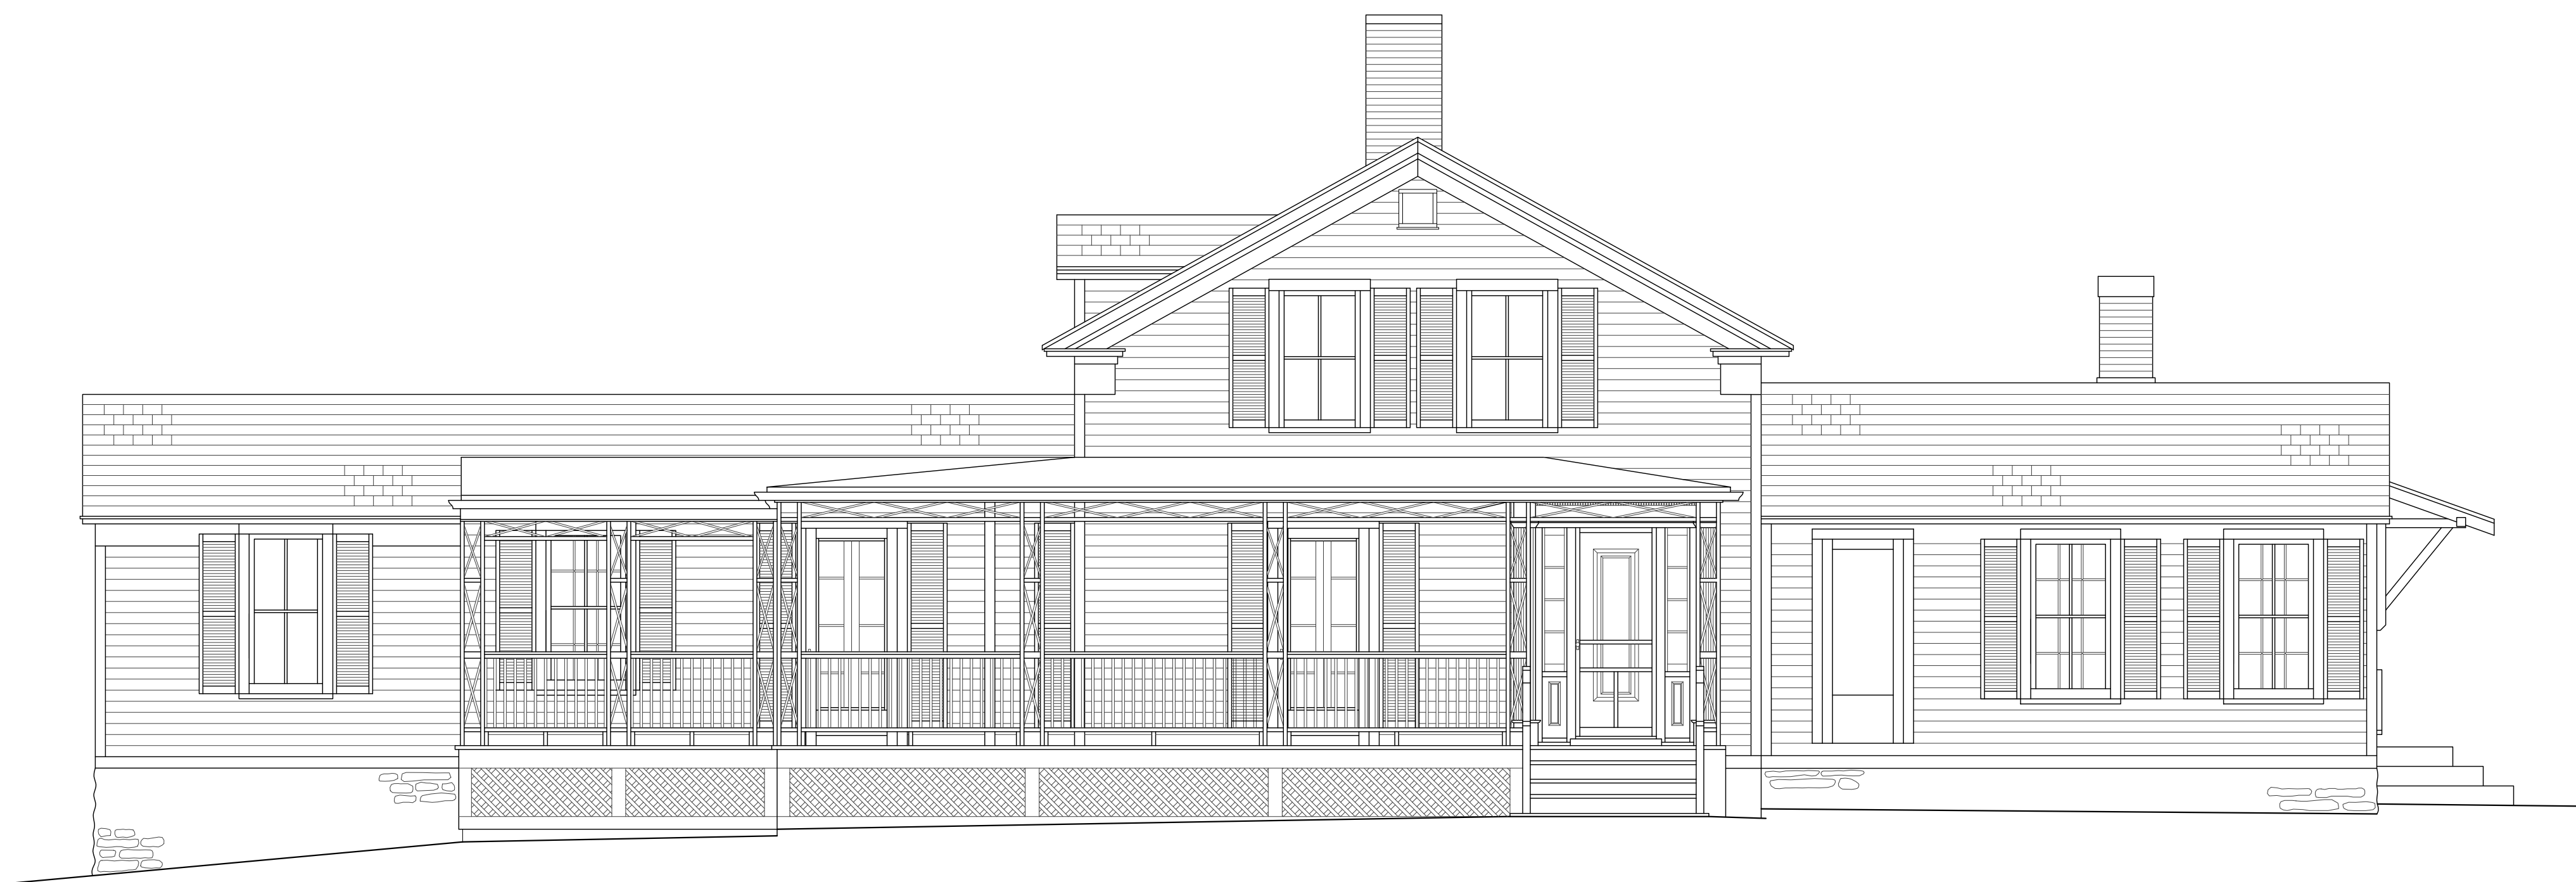
1 North Elevation
Scale: 1/4" = 1'-0"
